#### UNITED STATES ENVIRONMENTAL PROTECTION AGENCY

Re: Multimedia Compliance Investigation at NLMK Indiana

Re. Notice of Violation NLMK Indiana

Photographer: Daniel Chachakis Location: Wastewater Treatment Area Subject: Used Oil Storage containers

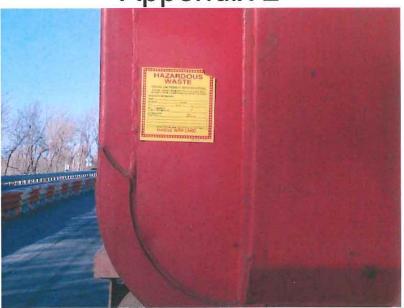
Figure 1: New label on vacuum box

Regardless of the above statement, we have applied "Hazardous Waste" labels to the vacuum boxes and can now record accumulation start dates. Images of this task's completion are attached here for your examination. Please see Appendix 2.

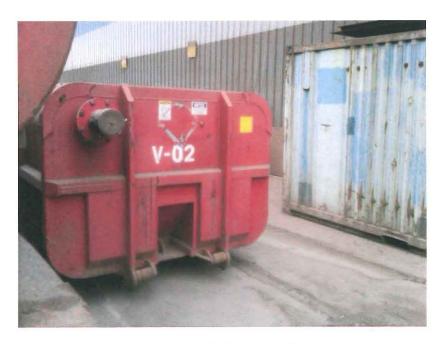
Figure 2: New label on vacuum box

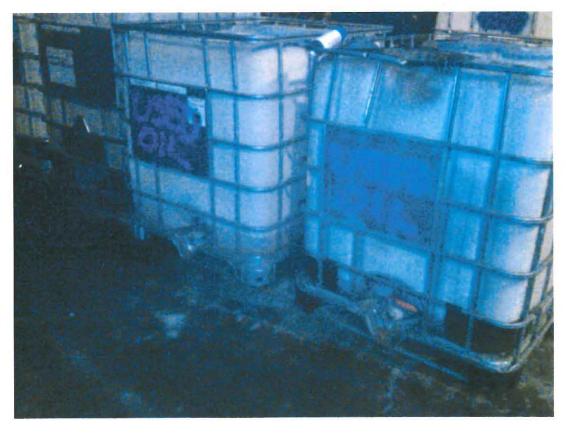
# Appendix 5: An example of a properly labeled used oil container

Figure 3: Properly labeled used oil containers. This site is located inside the facility building.

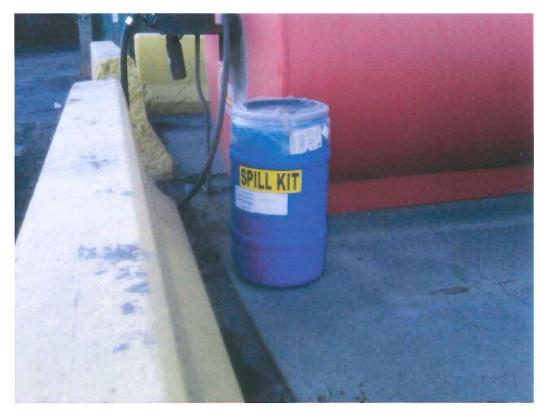
## Appendix 6.1: Spill Kit Example

Figure 4: Example of typical spill kits deployed around the facility in high risk areas, 10 total. These are to be used to control oil releases, to limit the extent of releases and to aid in cleanup activities. This intersects with SPCC requirements.

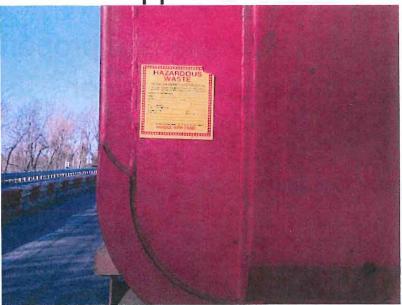
Figure 1: New label on vacuum box

Regardless of the above statement, we have applied "Hazardous Waste" labels to the vacuum boxes and can now record accumulation start dates. Images of this task's completion are attached here for your examination. Please see Appendix 2.

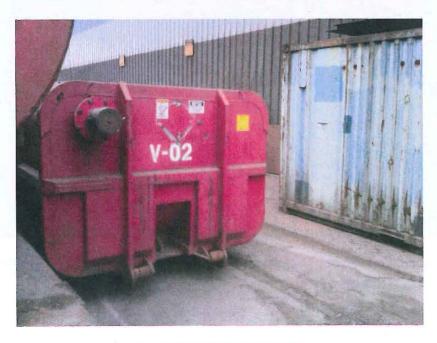
Figure 2: New label on vacuum box

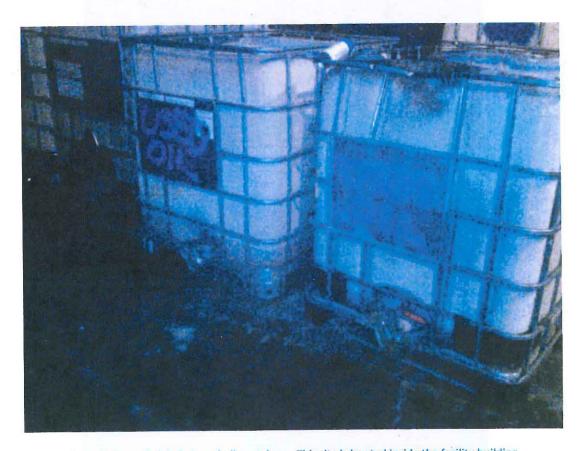
# Appendix 5: An example of a properly labeled used oil container

Figure 3: Properly labeled used oil containers. This site is located inside the facility building.

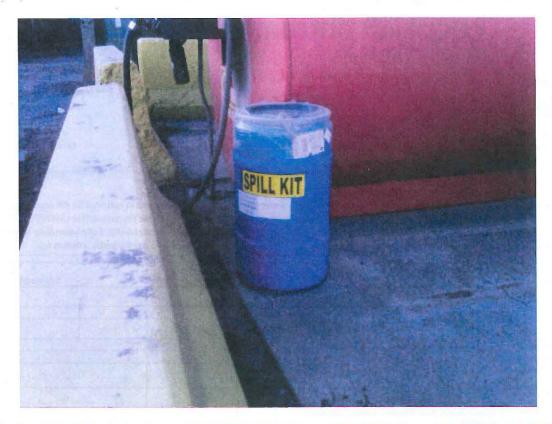
## Appendix 6.1: Spill Kit Example

Figure 4: Example of typical spill kits deployed around the facility in high risk areas, 10 total. These are to be used to control oil releases, to limit the extent of releases and to aid in cleanup activities. This intersects with SPCC requirements.

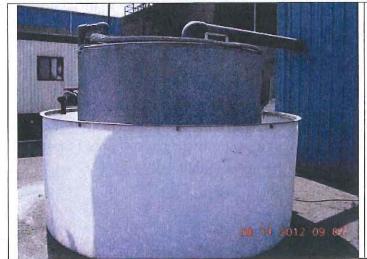
Picture #: 3
Facility: NLMK
Date: June 11, 2012

I observed, and took a picture of, a tank without a label (Picture 3). Mr. Hudson stated that the facility generates sludge in this tank and other used oil tanks; and that the tank is part of the wastewater treatment system.

Photographer: Daniel Chachakis Location: Wastewater Treatment Area Subject: Used Oil Storage Tank w/o label I observed, and took a picture of, cardboard containers (Picture 4).

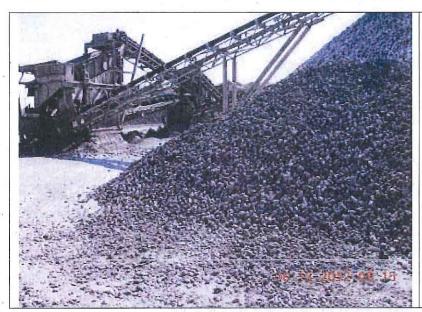
Picture #: 30 Facility: NLMK Date: June 11, 2012

We walked the site. I observed, and took a picture of, a pile of 3" thick slag (Picture 30)

Subject: Slag Pile

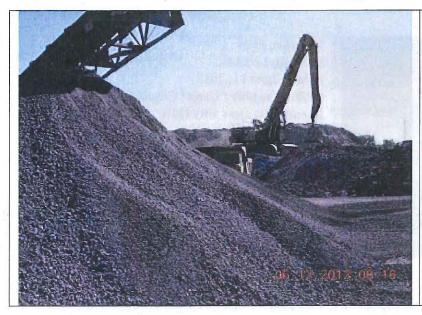
Picture #: 31 Facility: NLMK Date: June 11, 2012

I observed, and took a picture of, what was described by Mr. Wieczorek as the "fines" file (Picture 31).

Location: Tube City IMS Subject: Fines Pile

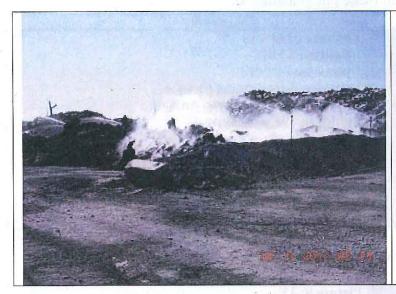
Picture #: 32 Facility: NLMK Date: June 11, 2012

I observed, and took a picture of, a slag pile undergoing the final quenching process (Picture 32).

Subject: Slag pile

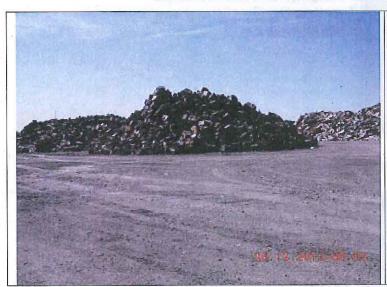
Picture #: 33
Facility: NLMK
Date: June 11, 2012

I observed, and took a picture of, a pile of scrap that NLMK will use after processing (Picture 33).

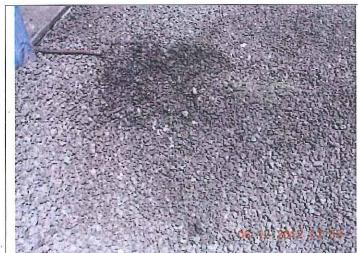
Picture #: 39 Facility: NLMK Date: June 12, 2012

We continued the walkthrough with Mr. Olson, specifically looking at Water program items of interest. I observed, and took pictures of, a compressor house with staining at the south end of the facility. Mr. Olson stated the material was an oil / water mix (Pictures 39).

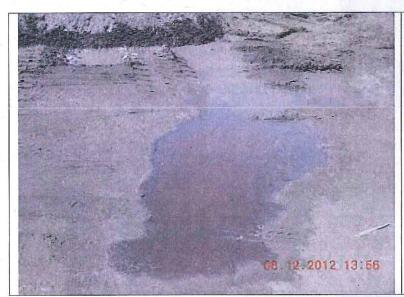
Picture #: 44
Facility: NLMK
Date: June 12, 2012

I observed, and took a picture of, an oil / water mixture potentially from a carbon pile (Picture 44).

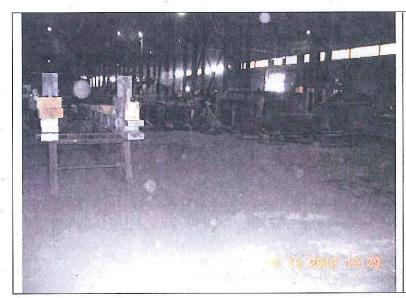
Picture #: 45
Facility: NLMK
Date: June 13, 2012

I observed the presence of dust on the equipment and on the floor. Mr. Olson stated that NLMK collects dust and places the dust in a bin next to the carbon bin. Mr. Olson stated that there was no hazardous waste determination completed for the dust.

We proceeded to the maintenance area. I observed, and took a picture of, the maintenance area, including the dust (Picture 45).

Regarding the allegation that NLMK Indiana has not determined whether "waste dust from the storage areas of the facility floor" is a hazardous waste: Based on EPA'S RCRA Compliance Evaluation Inspection Report (the "Report"), NLMK Indiana understands EPA to be referring to dust EPA's inspector observed on the main floor of the Melt Shop that is not added back into the process. NLMK Indiana has determined that the dust is not a hazardous waste, but understands that it is not able to provide documentation of its determination. NLMK Indiana will make another hazardous waste determination on the dust and retain written documentation of its determination.

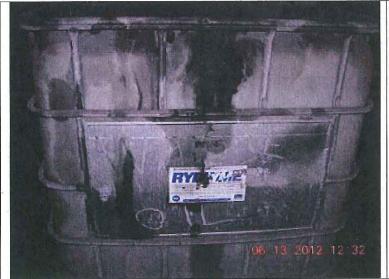
Picture #: 46
Facility: NLMK
Date: June 13, 2012

I observed, and took a picture of, a "waste oil" marking (Picture 46).

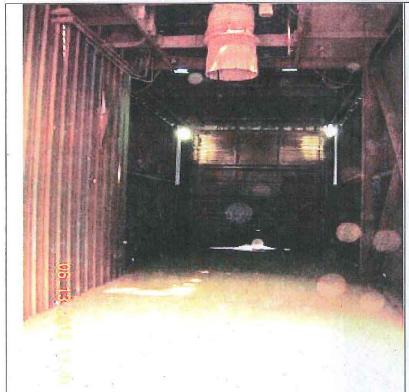
Picture #: 51 Facility: NLMK Date: June 13, 2012

We proceeded to the bag house. I observed, and took a picture of, the load point (Picture 51).
